DEPARTMENT OF TRANSPORTATION

Quality Assurance and Source Inspection

Contract #: 04-0120F4Cty: SF/ALA Rte: 80 PM: 13.2/13.9File #: 69.28**WELDING INSPECTION REPORT****Resident Engineer:**Siegenthaler, Peter**Address:** 333 Burma Road**City:** Oakland, CA 94607**Report No:** WIR-025641**Date Inspected:** 03-Aug-2011**Project Name:** SAS Superstructure**OSM Arrival Time:** 700**Prime Contractor:** American Bridge/Fluor Enterprises, a JV**OSM Departure Time:** 1900**Contractor:** Zhenhua Port Machinery Company, Ltd (ZPMC), Changxing Island **Location:** Shanghai, China**CWI Name:** An Qing Xiang**CWI Present:** Yes No**Inspected CWI report:** Yes No N/A**Rod Oven in Use:** Yes No N/A**Electrode to specification:** Yes No N/A**Weld Procedures Followed:** Yes No N/A**Qualified Welders:** Yes No N/A**Verified Joint Fit-up:** Yes No N/A**Approved Drawings:** Yes No N/A**Approved WPS:** Yes No N/A**Delayed / Cancelled:** Yes No N/A**Bridge No:** 34-0006**Component:** OBG**Summary of Items Observed:**

SHIP # 19, OBG SEGMENT 14E

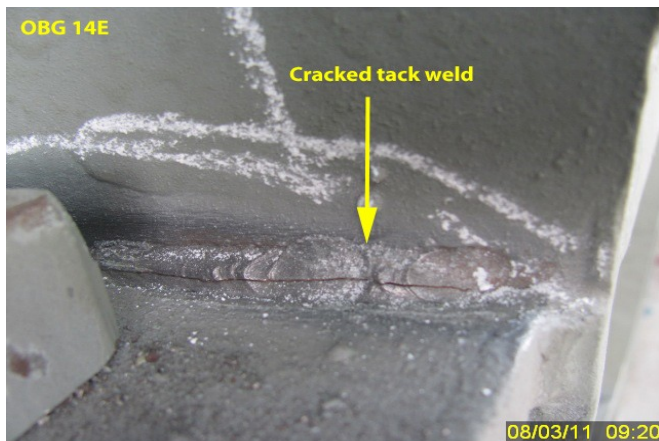
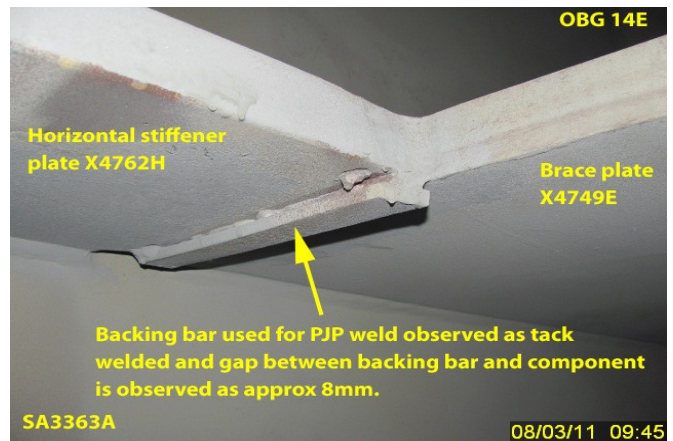
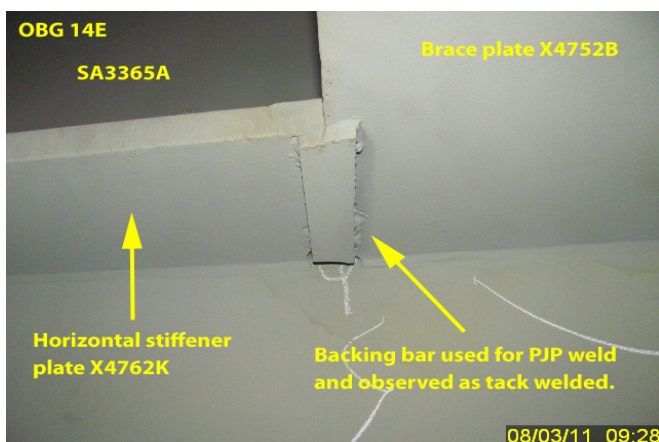
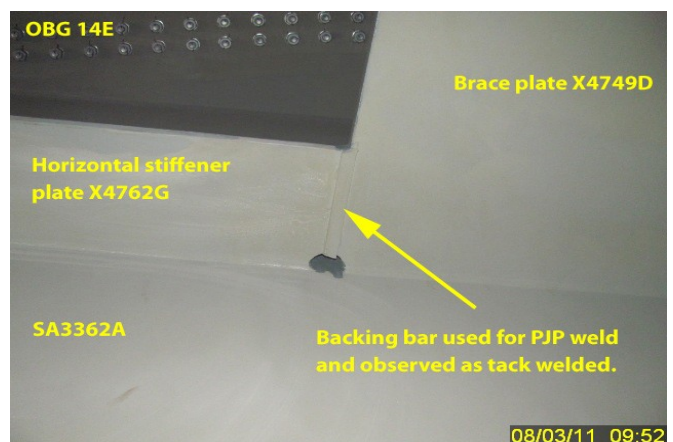
Weld joint joining horizontal stiffener plate X4762K to brace plate X4752B on vertical shear plate SA3365A at PP 126 welded with steel backing bar. The steel backing bar is observed as tack welded. As per shop drawing and weld details this weld is shown as Partial Joint Penetration (PJP).

Weld joint joining horizontal stiffener plate X4762H to brace plate X4749E on vertical shear plate SA3363A at PP 126 welded with steel backing bar. The steel backing bar is observed as tack welded and the gap between backing bar and component is observed as approx 8mm. As per shop drawing and weld details this weld is shown as Partial Joint Penetration (PJP).

Weld joint joining horizontal stiffener plate X4762G to brace plate X4749D on vertical shear plate SA3362A at PP

126 welded with steel backing bar. The steel backing bar is observed as tack welded. As per shop drawing and weld details this weld is shown as Partial Joint Penetration (PJP).

Cracked tack observed on weld joints joining following parts.

Anchorage connection plates X4763B and X4764B to vertical shear plate SA3358A.

Anchorage connection plate X4764C to vertical shear plate SA3359A.

Anchorage connection plates X4763D and X4764D to vertical shear plate SA3360A.

Anchorage connection plate X4764F to vertical shear plate SA3362A.
